■ Pre-purchase bridge inspection

Pre-sale bridge INSPECTION

Shortline start-ups have their share of problems. A solid inspection, especially of bridges, can keep the problems to a minimum.

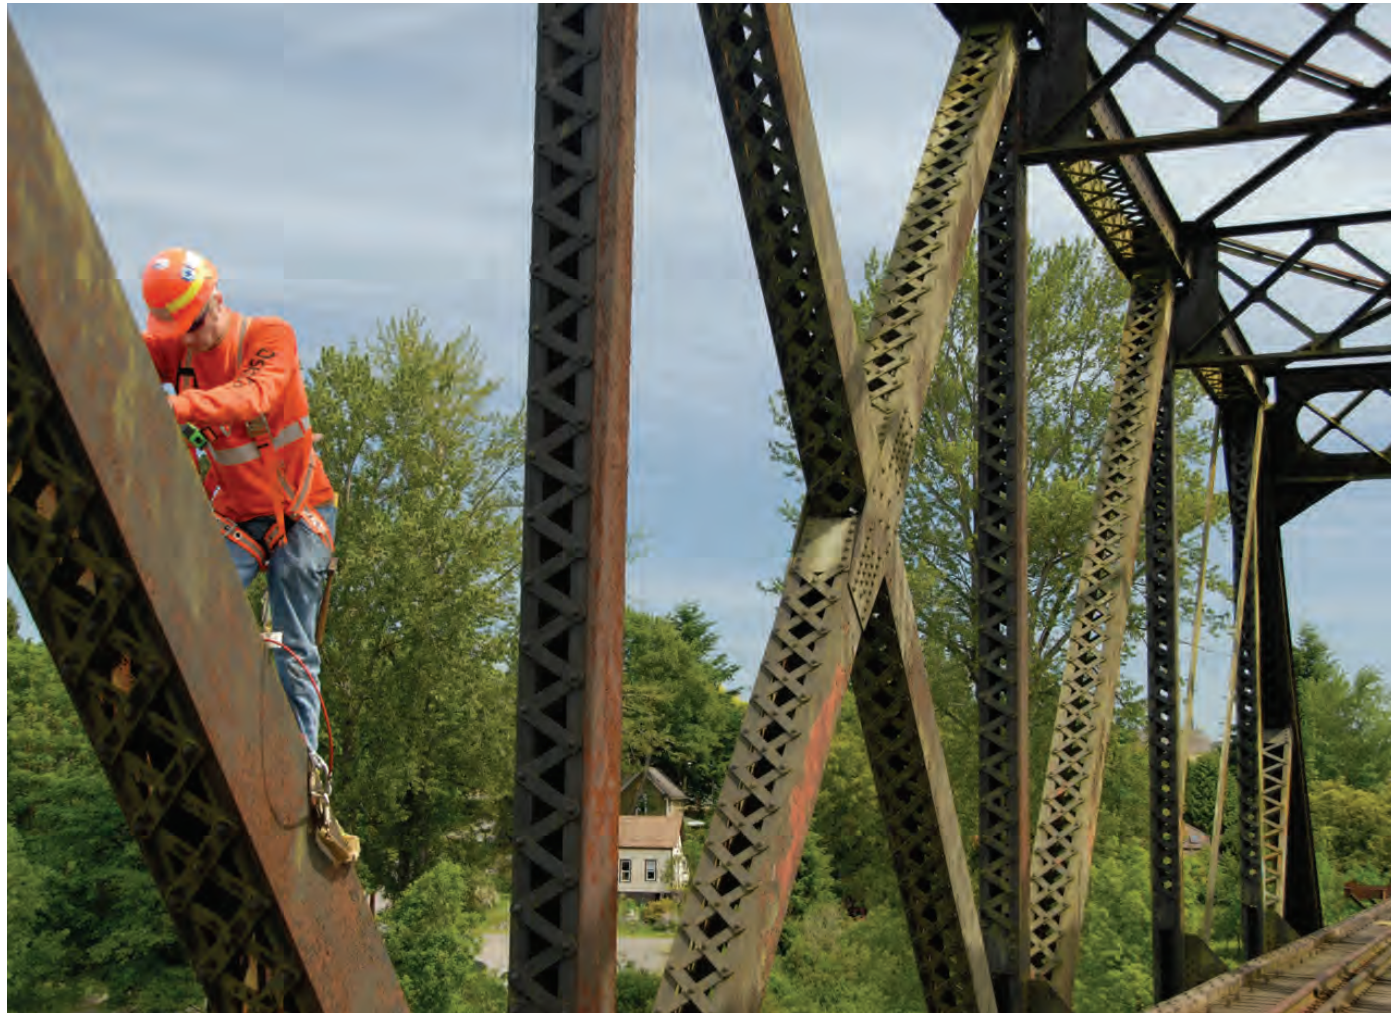
Osmose points out that the inspection of a steel thru truss is not accurate unless you actually physically climb over the upper chords and underneath the bottom chords. Corrosion, missing rivets and crack identification are key priorities during the steel inspection.

“The climbing did not stop with the timber crew, either,” Tweet noted. “The inspection of a steel thru truss is not accurate unless you actually physically climb over the upper chords and underneath the bottom chords. Corrosion, missing rivets and crack identification are key priorities during the steel inspection. It gets even tougher when you factor in the weather (windy and rainy) and the difficulty of climbing up to places that most people would not even think of going.

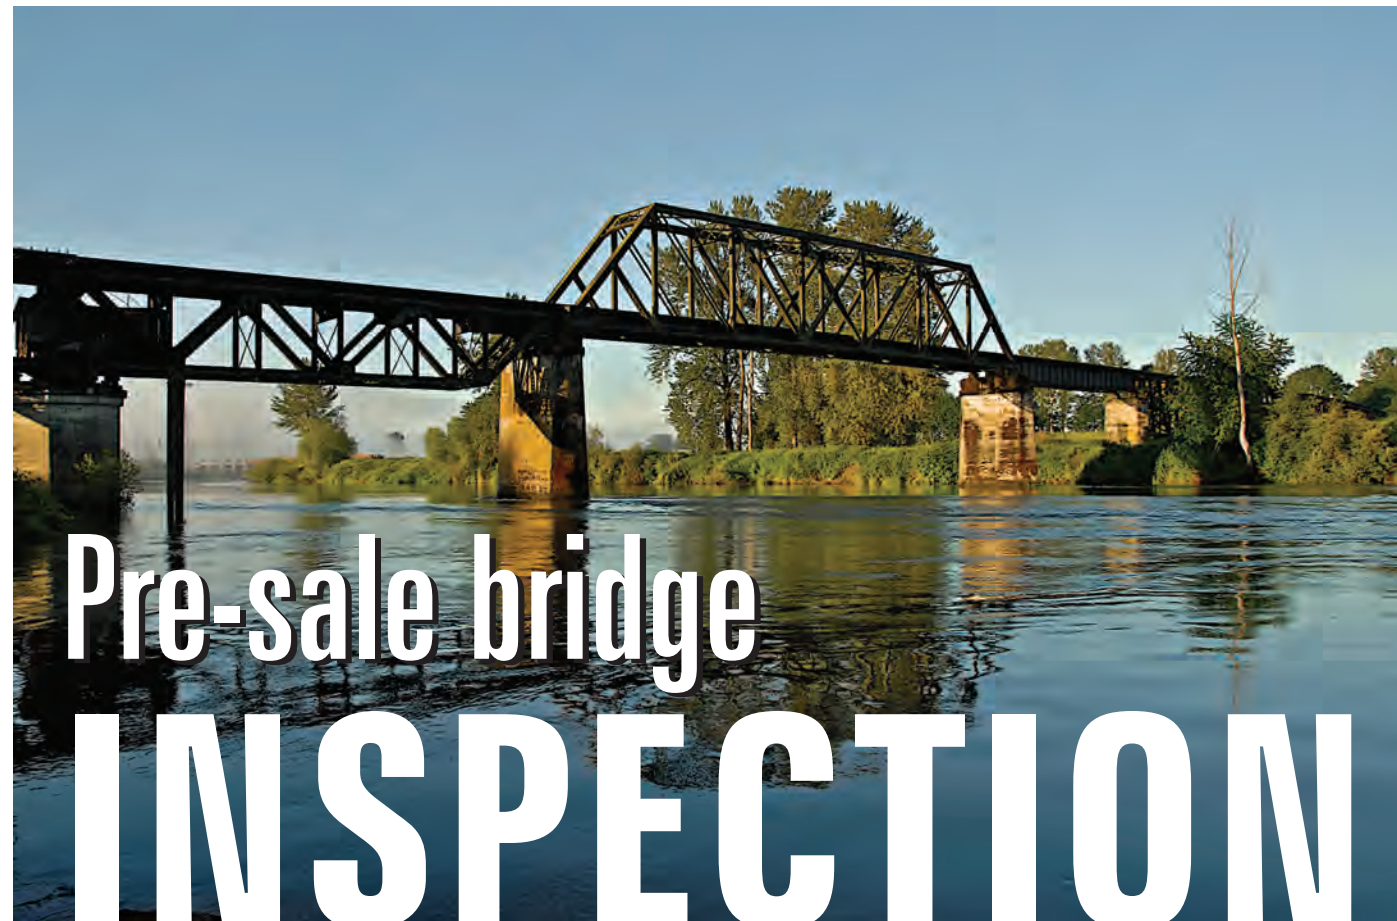
The GNP Railway bridge that crosses the Snohomish River includes large timber approaches into a thru truss and then a deck plate girder followed by more large timber approaches set up in an S curve.

This line is unique as it ends in Snohomish over the unpredictable Snohomish River. The bridge that crosses the river is comprised of large (tall) timber approaches into a thru truss and then a deck-plate girder followed by more large

timber approaches set up in an S curve. Add in all the other bridges and the GNP had a commitment to the community to document the structural integrity of these structures.

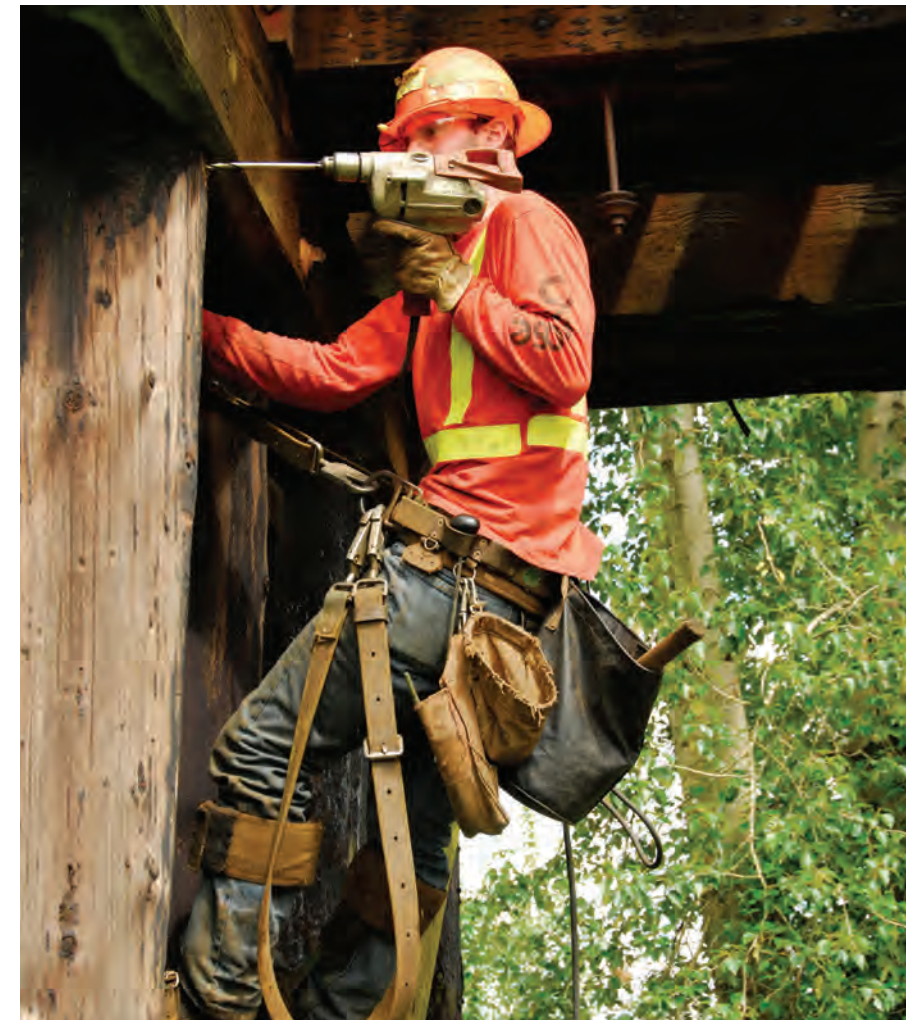
Osmose obtained detailed information on the piling, caps and stringers using the company’s proven methods of hammer sounding, boring and quantifying the results by measuring shell and void in the timber members.
